INNOTRACK

D4.4.3 - Evaluation of an Inspection Demonstrator (Phase 2: Track Tests)

University of Birmingham

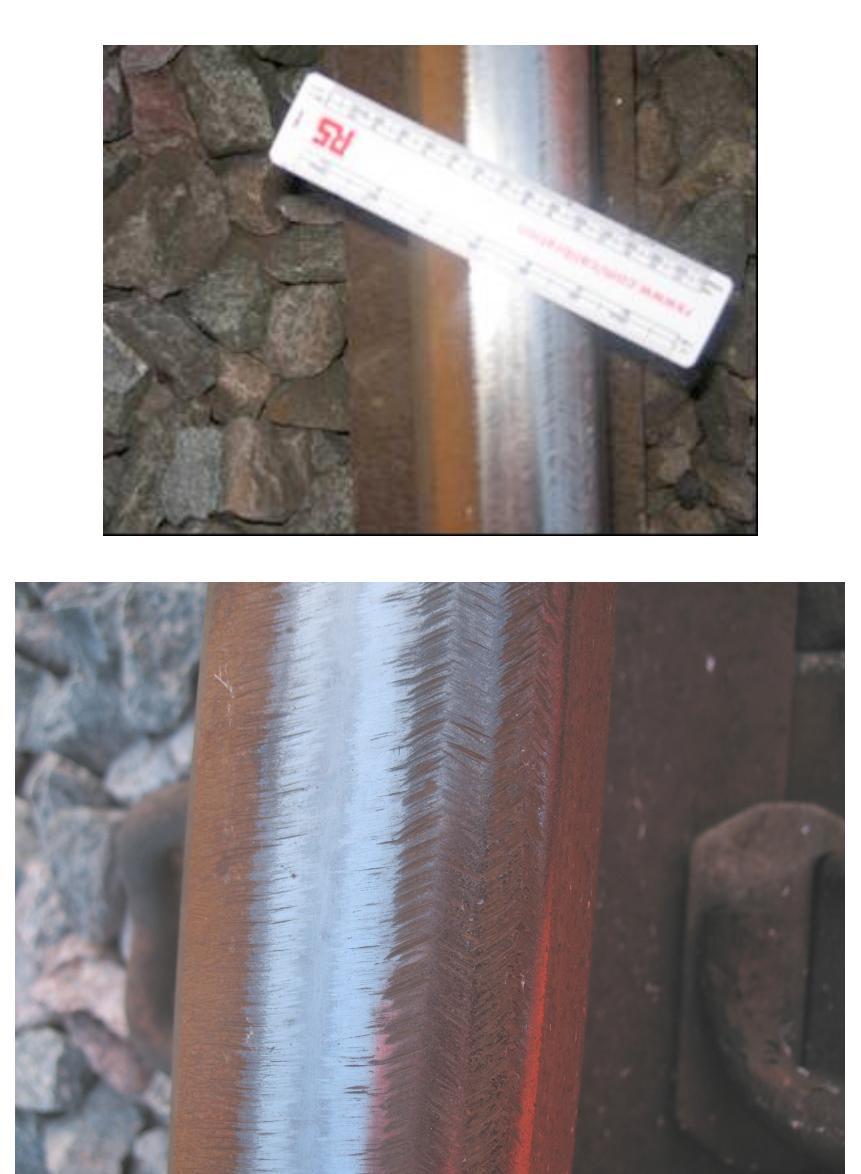
cracks during ultrasonic testing and visual inspection conducted by Network Rail,. The tracks were ground prior to the inspection trials as shown in Figure 1.2.

Figure 1.2 - Photograph showing the quality of the surface of the rail sections inspected during the Swindon *trials*

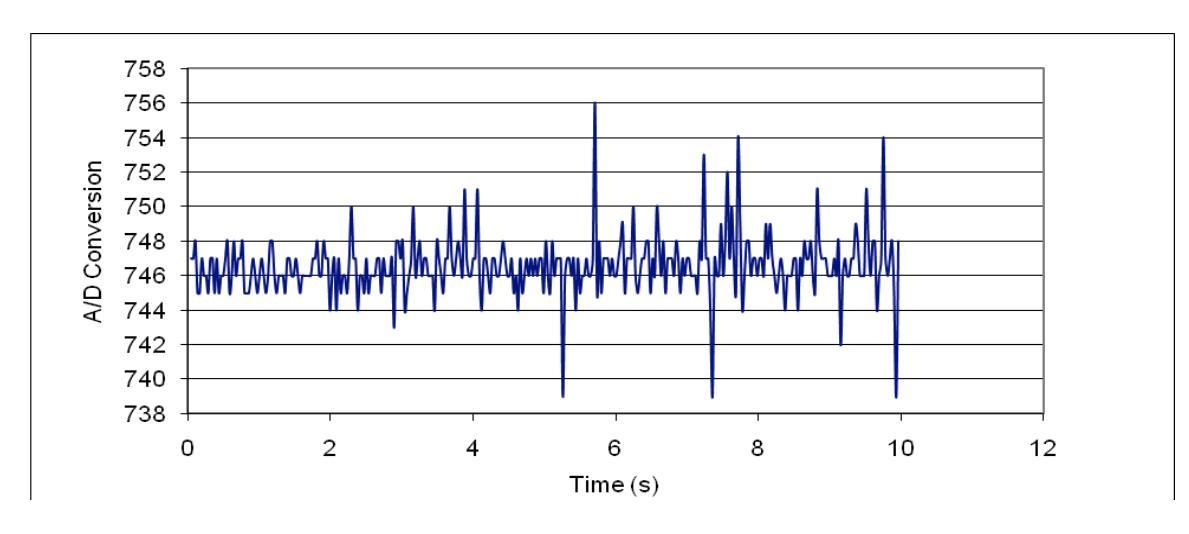
Initially, manual ACFM tests (i.e. without the use of the trolley) were carried out. Figure 2.9 shows the ACFM response obtained during manual rail inspection at the Swindon test site over an area of 200 mm. Some small RCF cracks can be identified.

Figure 2.9 - Manual ACFM inspection response from Swindon test site

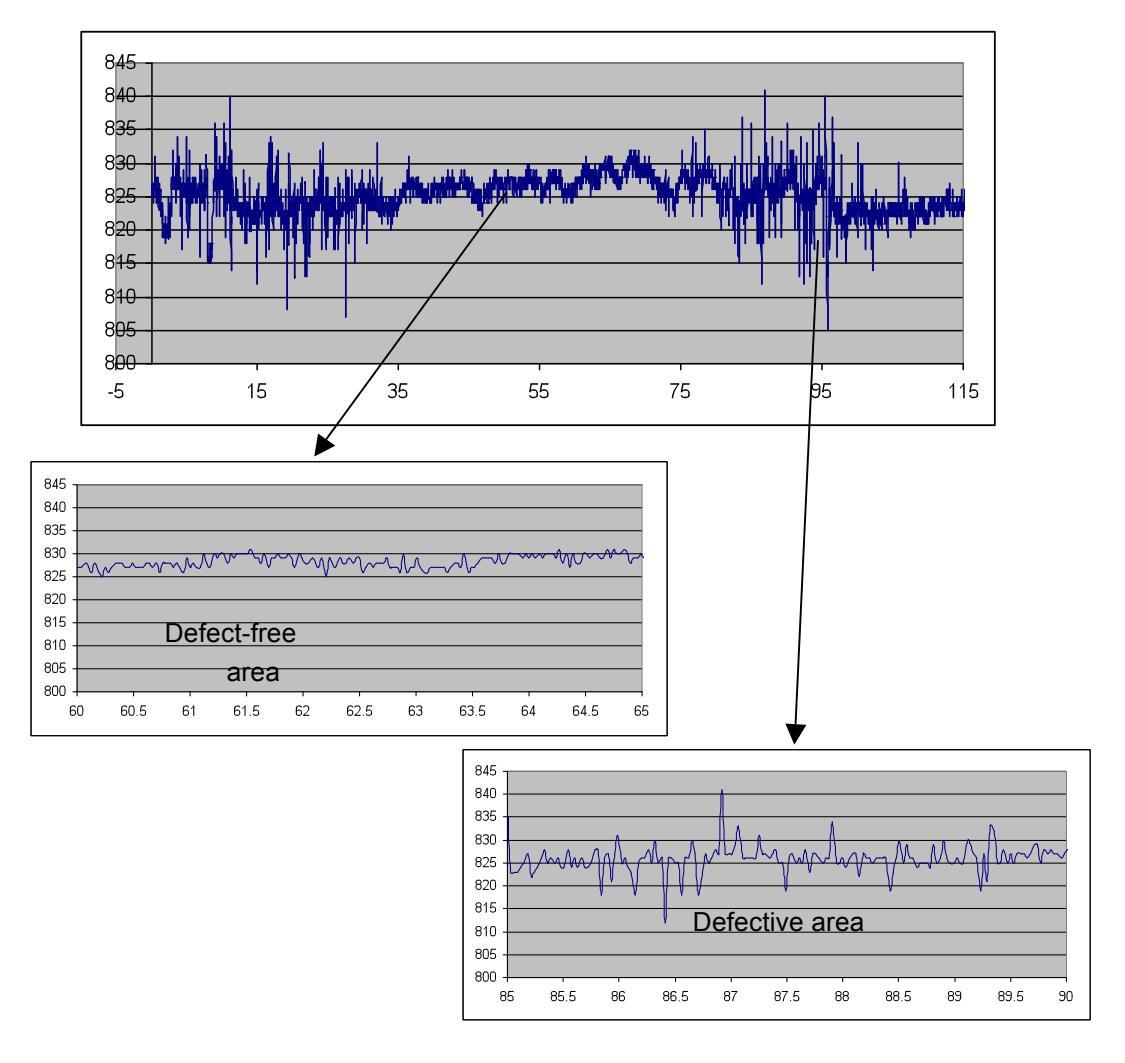
Figure 2.11 - Trolley inspection results for the rail section identified to contain light RCF cracking

The inspection of the light RCF section revealed that there were RCF cracks present, albeit not throughout the entire length of the rail. It also appeared that certain areas potentially contained small clusters of RCF cracks. The second diagram in Figure 2.11 shows the ACFM signal over an area of the inspected rail section containing no defects whilst the third (bottom) diagram shows the ACFM response over an area containing RCF cracking.

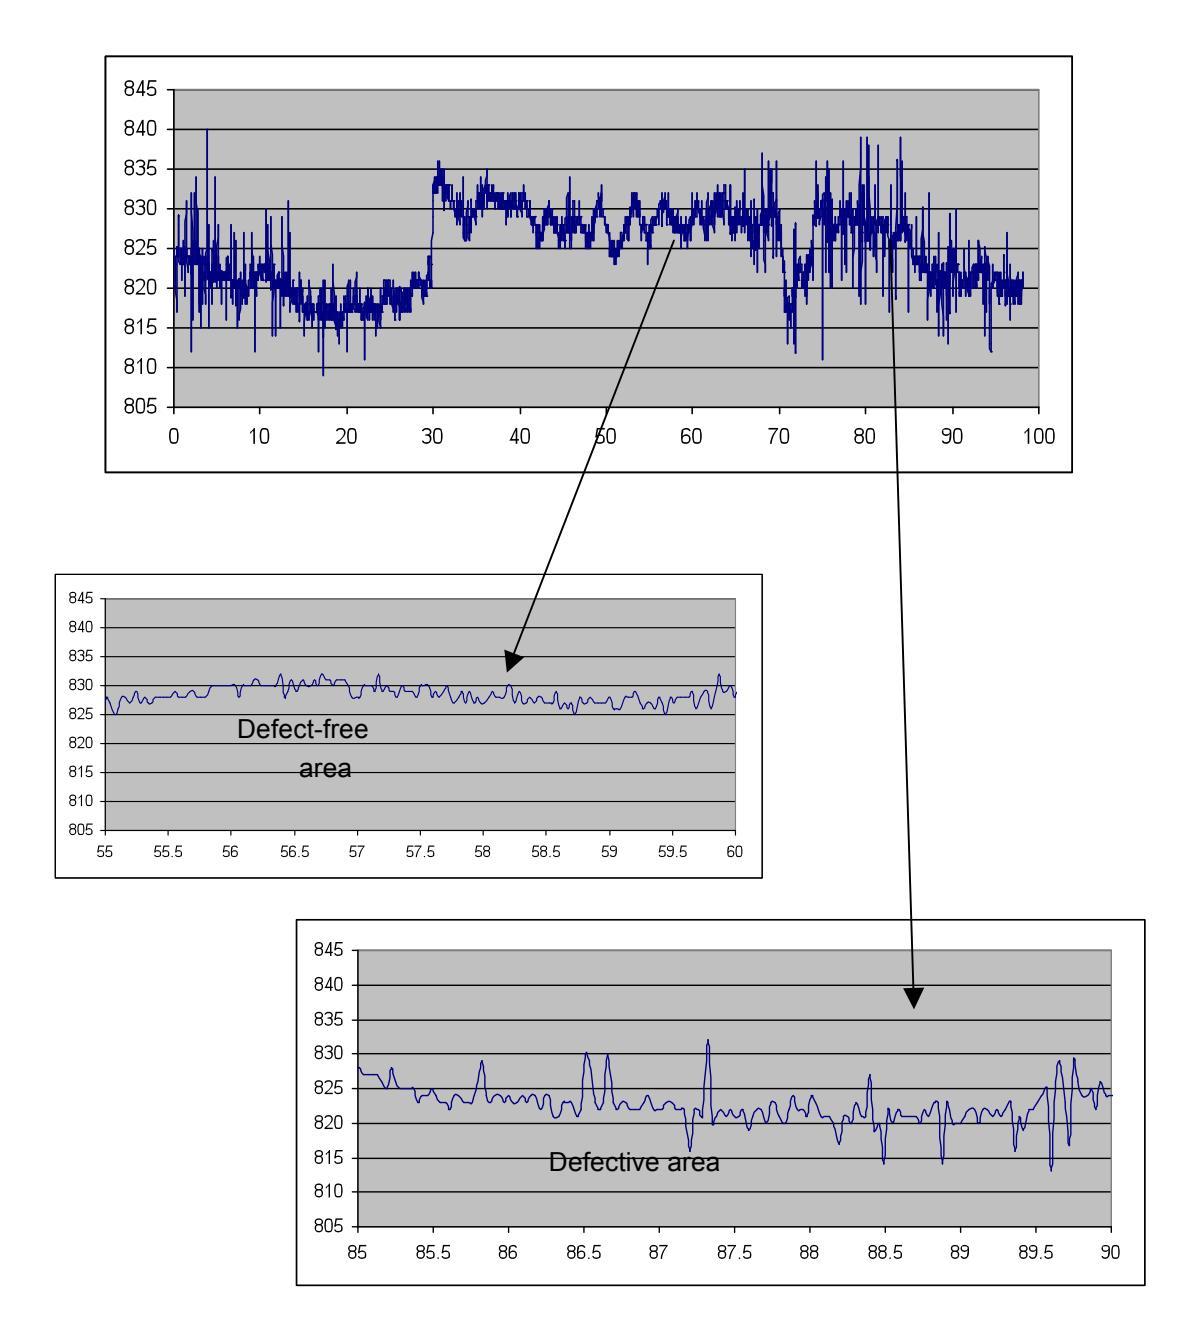
Figure 2.12 - ACFM trolley inspection results for the rail section identified to contain moderate RCF cracking

The inspection of the moderate RCF section showed that there were RCF cracks present with a similar, but slightly more dense, distribution as compared to the light-RCF rail section.

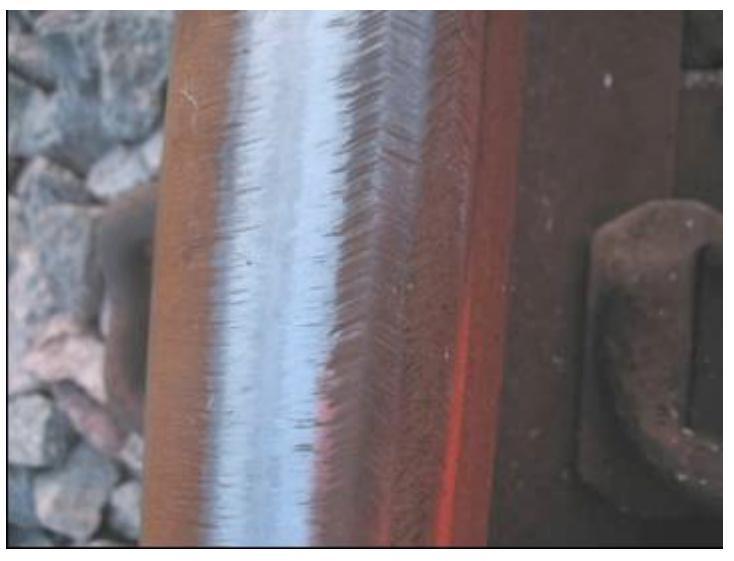
Problems with the rail defect identification software meant that it was unable to identify any defects. One of the reasons for this is that the site had recently been ground, resulting in extensive residual grinding marks, as shown in Figure 3.3.

Figure 3.3 - Digital photograph of rail condition

The grinding relocated the running band from the gauge corner to the centre of the rail head, resulting in any RCF cracks present being disguised by the residual grinding marks. The suboptimal trolley set up also made the identification of defects difficult. Magnetic particle inspection (MPI) of the rail where the RCF was thought to be most severe revealed that only a few small cracks were present, as those reported by NR had probably been removed by grinding.

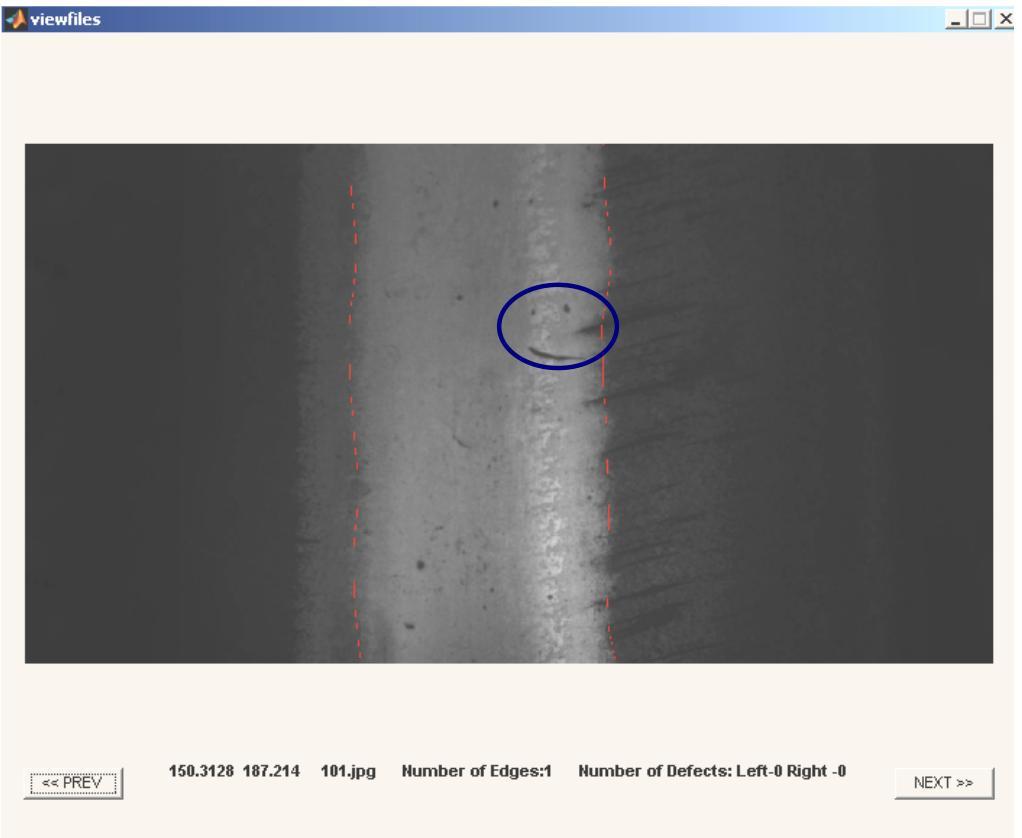
Some surface defects that were thought unlikely to be RCF were observed within the running band, an example is given in Figure 3.4.The software was unable to find these isolated defects as the system is optimised to find RCF and these defects were at a different orientation.

Figure 3.4 - Image from trolley of surface defect in running band

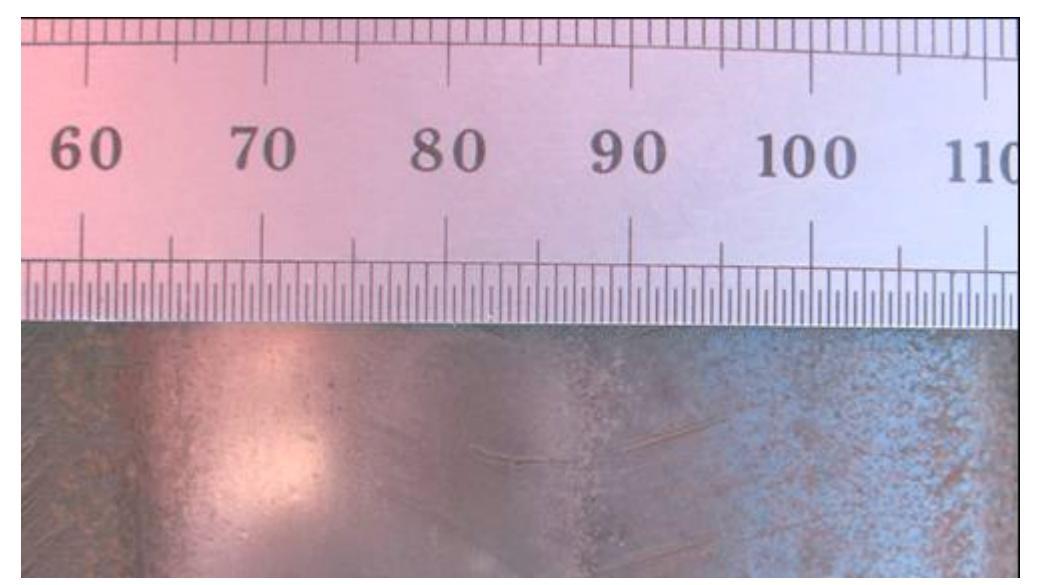
A detailed investigation of these defects was undertaken during the site visit using Alternating Current Potential Difference (ACPD) equipment, which had been calibrated for grade R220 rail, the defect was found to be approximately 0.1mm deep.

Figure 3.5 - Digital photograph of surface defect.

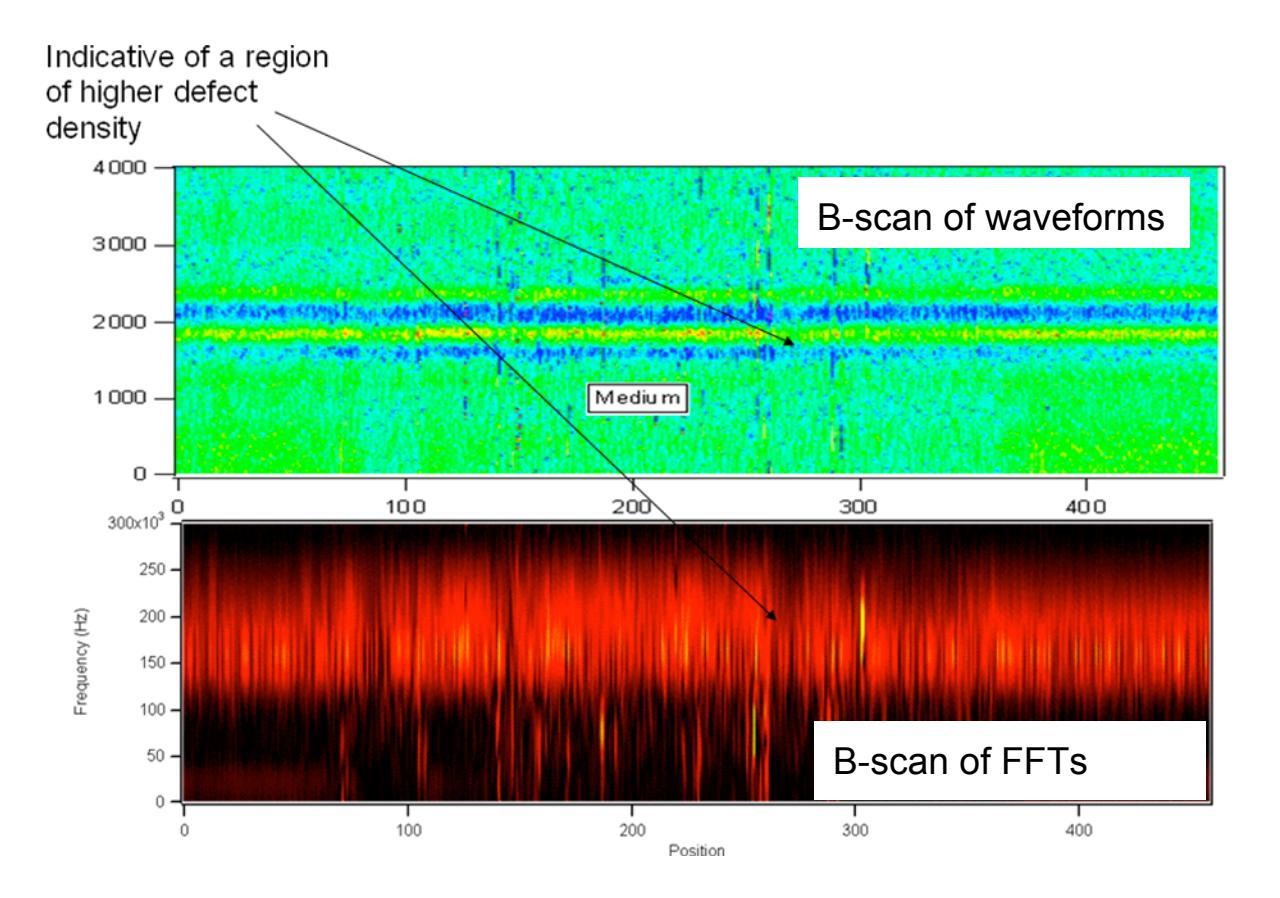
Figure 4.4 - The time domain waveforms and FFTs stacked side-by-side where the horizontal axes are related to the position along the rail

There is evidence in the time domain waveforms and the FFTs that electrical noise spikes are present in the data. The source of these is as yet unknown, but this noise can be eliminated either by improvement of equipment shielding during tests and/or signal processing.

The EMATs data clearly shows that there appear to be regions where both the amplitude and high frequency content of the surface waves fall, which would be consistent with the presence of defects. No major falls in amplitude appear to have been recorded, suggesting that there are no very deep (>20 mm) defects in the sections of track that were tested.
