INNOTRACK

D1.2.2

Track Sections and Track Irregularities Analysis of DB Sites

Deutsche Bahn AG

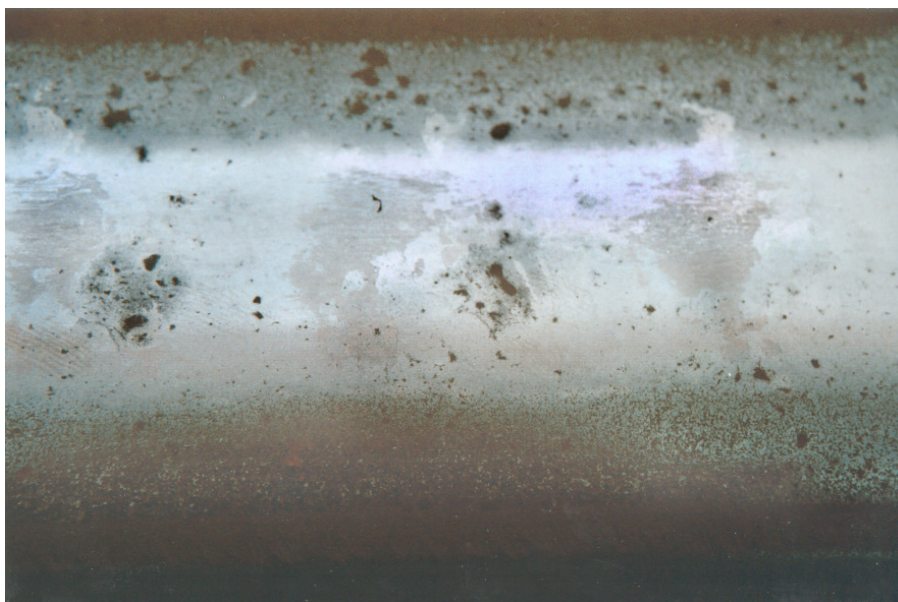
Figure 4: Belgrospi of category 3; source DB regulation 821.2007A02

Belgrospis are special rail failures of high-speed lines (see **Figure 4**). Belgrospis occur mainly in connection with short-wave-corrugation on places with corrugation wave depth $> 3/100$ mm, as consequence of higher stresses on the crests of waves. They develop as indentations and cracks on crests of waves and can be found as single failures or failure groups (nests).

This type of rail failure occurs only in sections with line speed $v \geq 200$ km/h and only in areas outside of tunnels.

On the DB track site 1, rail failures Belgrospi appeared for the first time ca. 10 years after opening the line. At present time they are the most problematical rail failure types on this track, because if Belgrospi are detected the rail has to be removed.

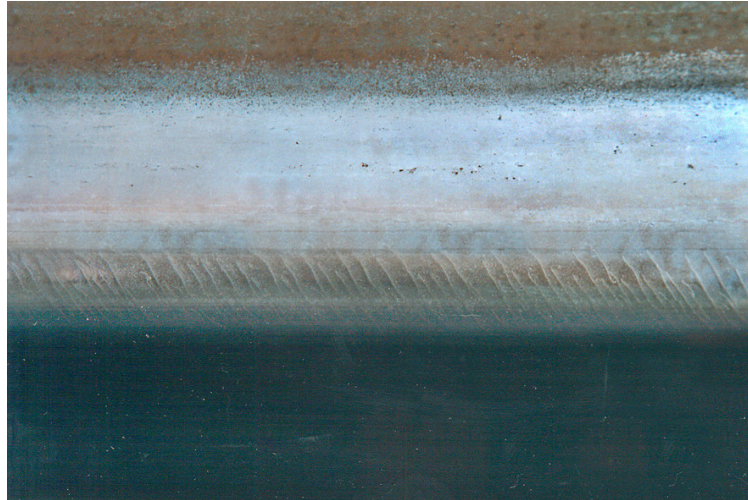
Figure 5: Head Check of category 3; source DB regulation 821.2007A02

Head checks develop as consequence of rolling contact fatigue and occur as surface cracks on the running surface of the rail (see **Figure 5**). This type of failure appears primarily in curves, but they can be found also on straight line sections, if the track geometry is in a poor condition.

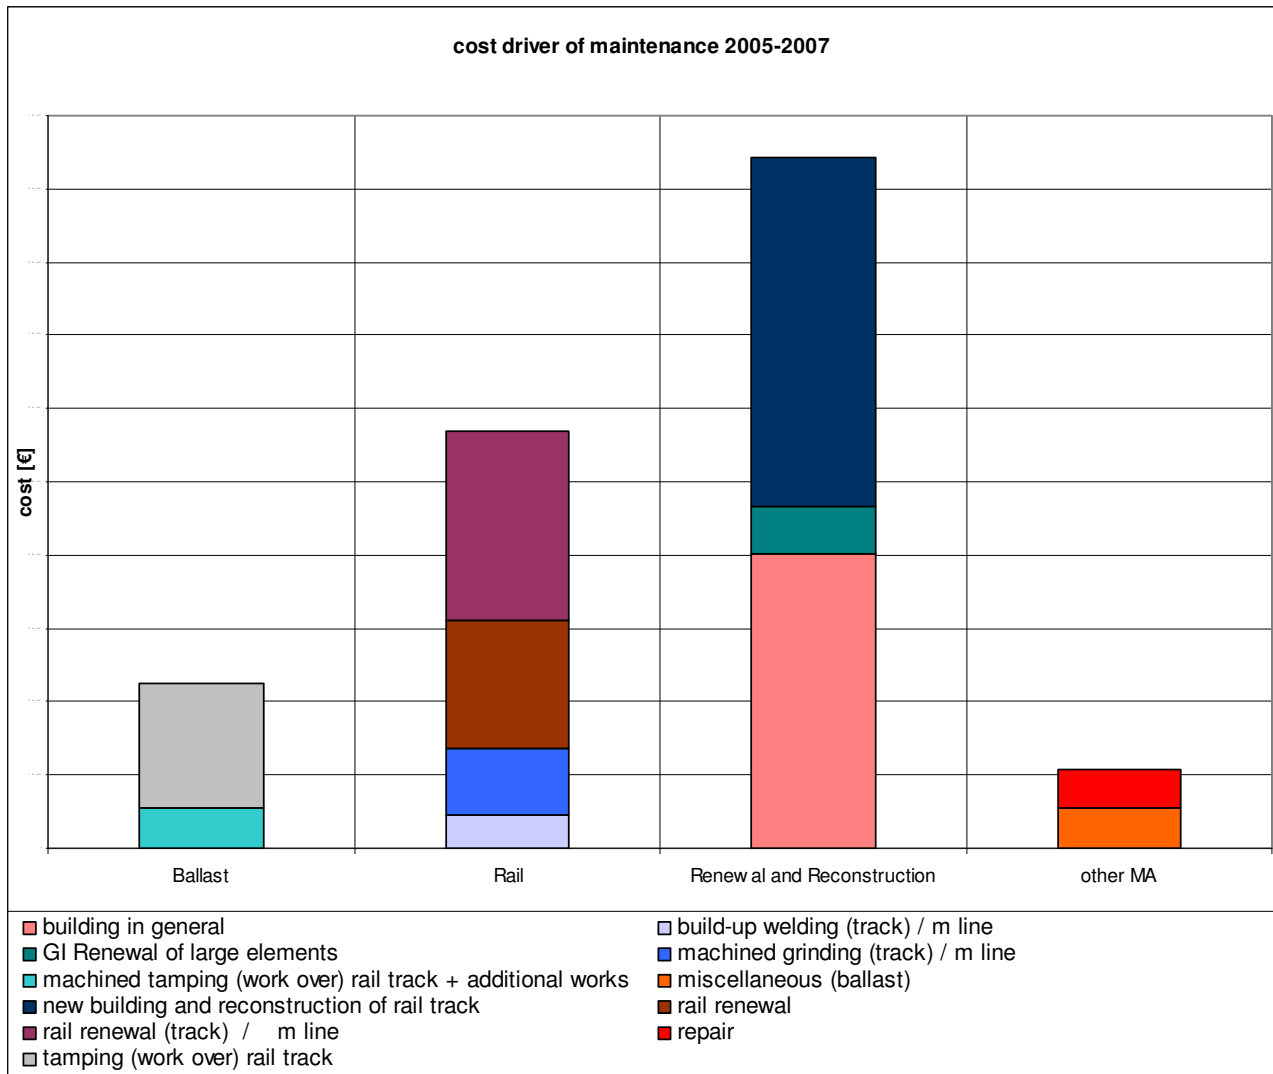
Figure 10: MA costs drivers of DB track site No. 1

The higher amounts of all incurred MA costs (inspection exclusive) have been selected out and presented as cost drivers in Figure 10.

It is obvious that the main costs have been generated by renewal and reconstruction, followed by rail maintenance costs.

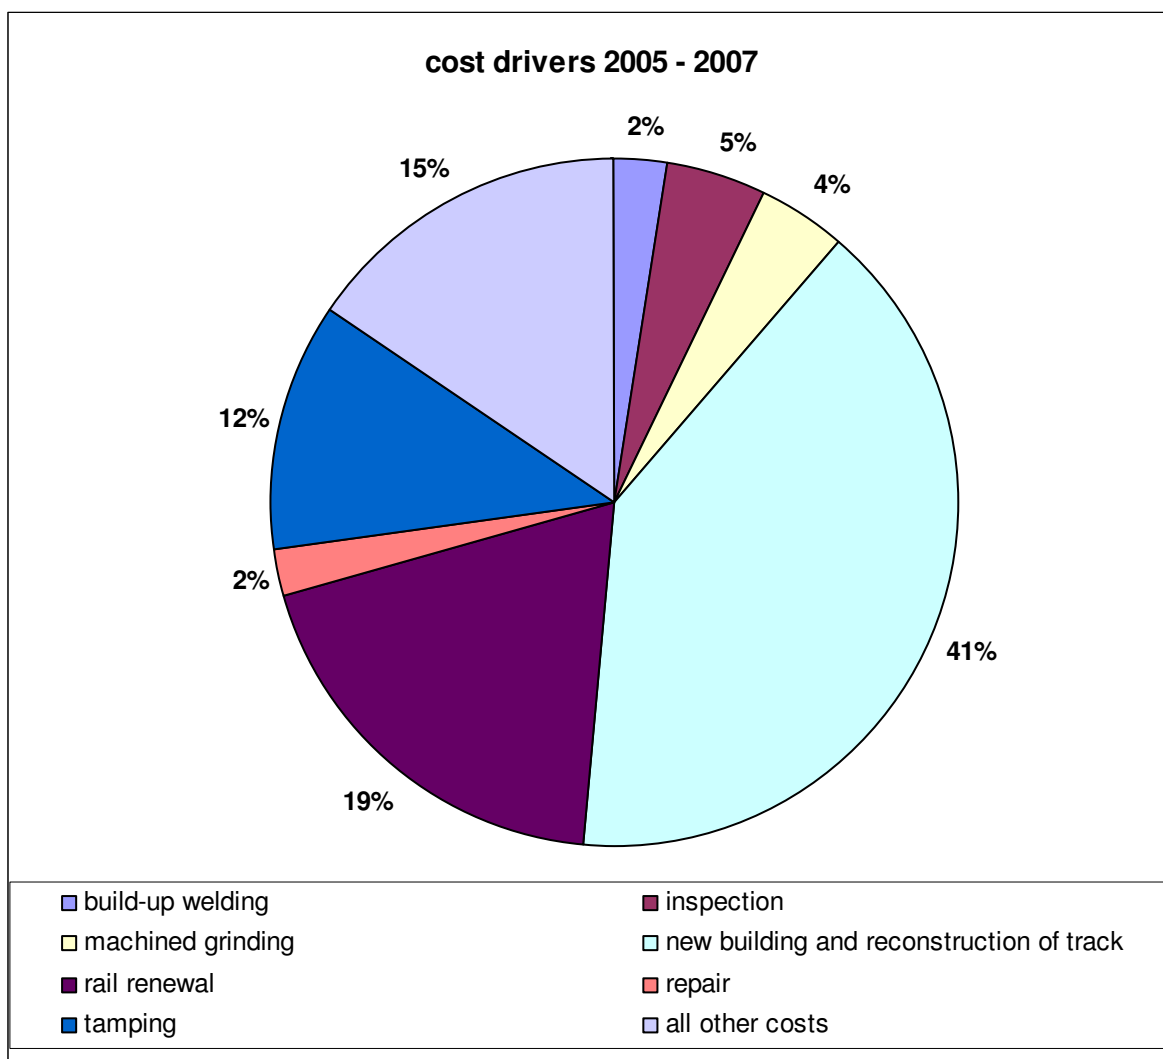
Figure 11: Cost driver distribution in relation to total costs

The cost distribution in relation to total costs within the analysed period is shown in Figure 11.

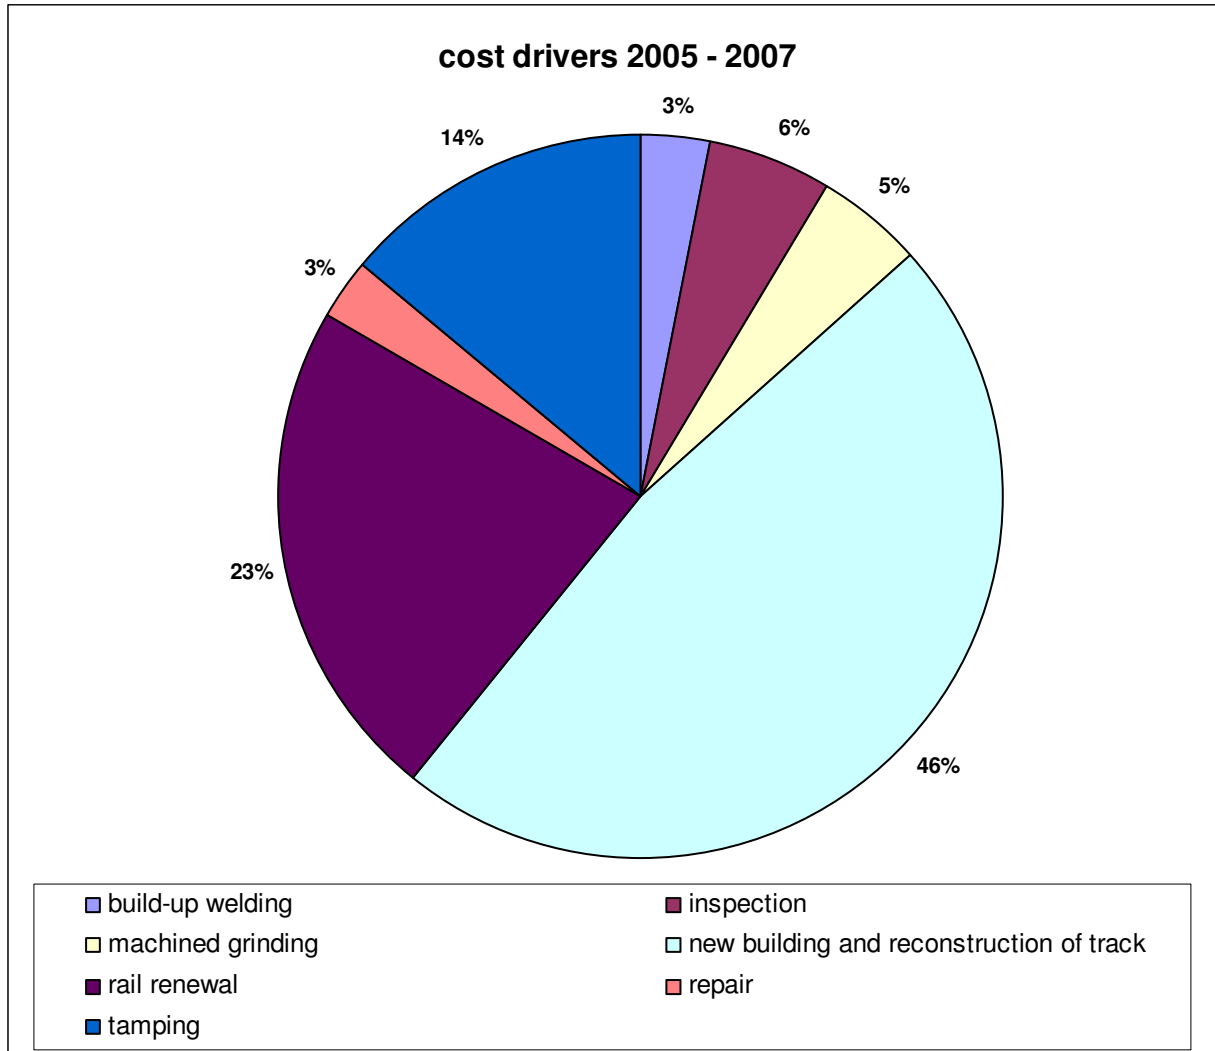
Figure 12: Cost driver distribution (“all other costs” excluded)

Figure 12 shows the cost distribution of the defined working categories without the category “all other costs”. Within these categories nearly half of the costs were caused by new building and reconstruction of track. Nearly a quarter of the costs were invested for rail renewal followed with 14 % for tamping. The rest of the costs were between 3 % and 6 %.
