INNOTRACK

D4.4.3 - Evaluation of an Inspection Demonstrator (Phase 2: Track Tests)

University of Birmingham

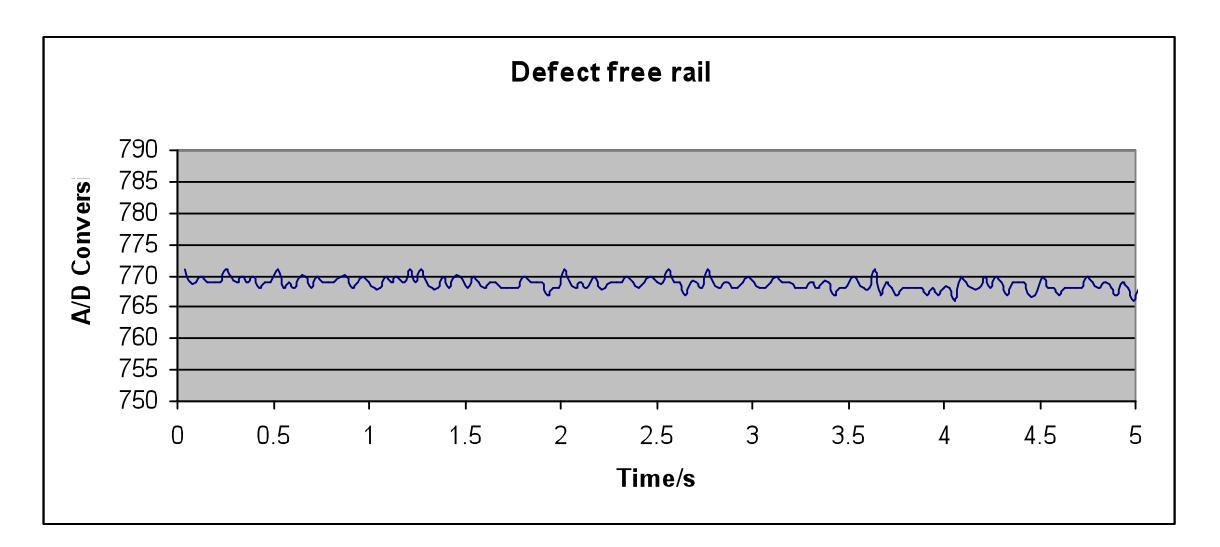
Figure 2.6 - Background ACFM signal versus time for a defect free rail

Manual tests without any lift-off were carried out on rails removed from service containing actual RCF cracking using a 5 kHz ACFM micro-pencil probe. Figure 2.6 shows the response for a rail without any defects present.

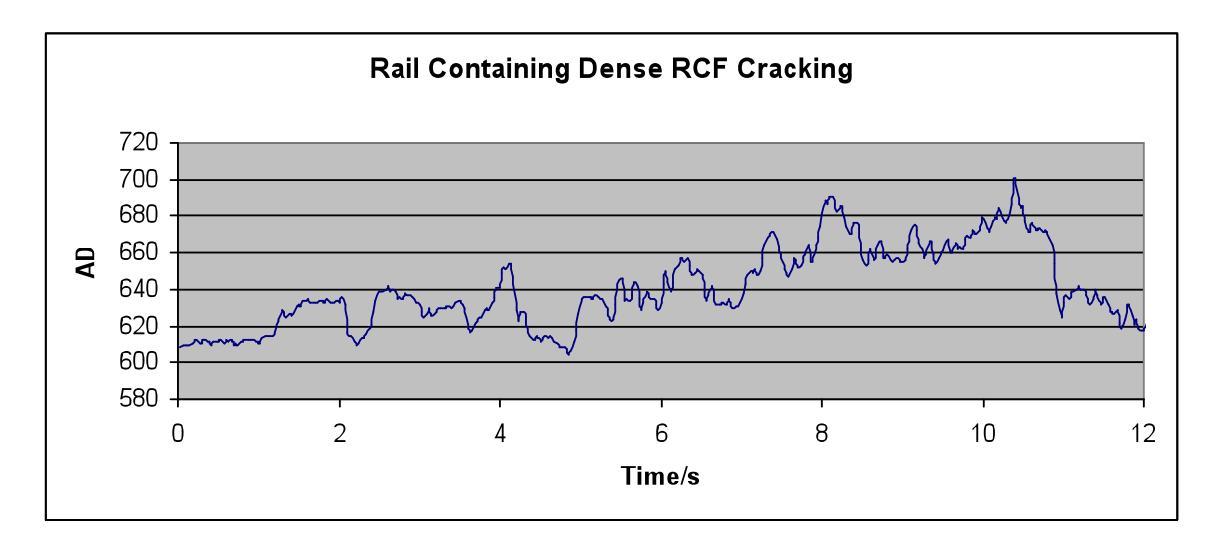
Figure 2.7 - ACFM signal versus time for a rail containing dense moderate RCF cracking

The diagram in Figure 2.7 shows the response obtained for a rail containing a dense population of moderate RCF cracks. From the signal no individual cracks can be resolved, however, it is clear that the damaged area gives rise to a varying ACFM signal, which can potentially be correlated to the severity of the damage.

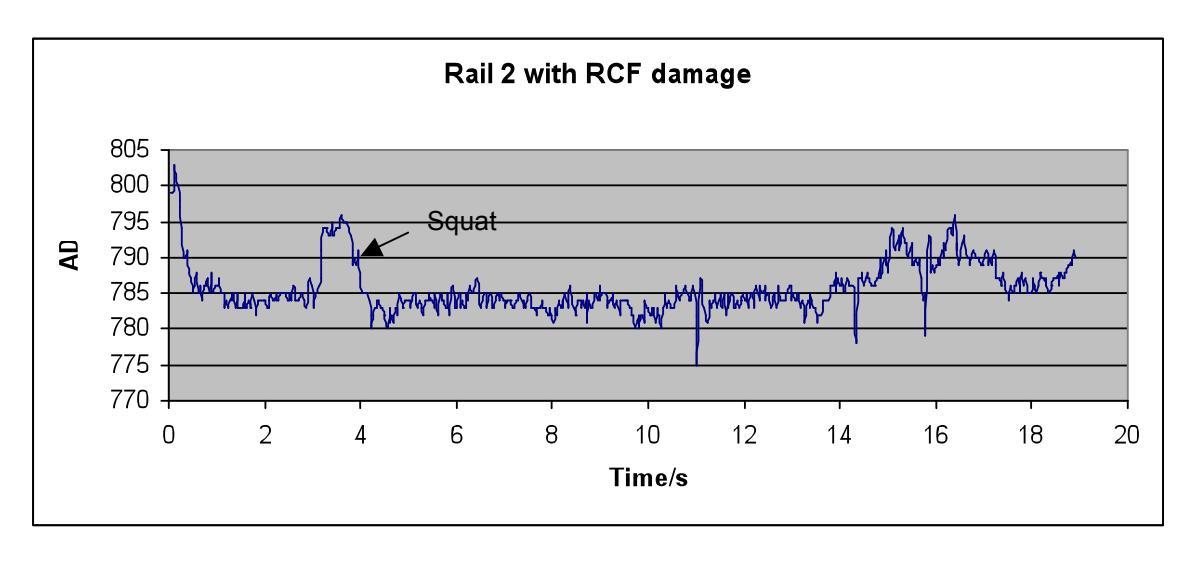
Figure 2.8 - ACFM signal versus time for a rail containing dense moderate RCF cracking

Figure 2.8 shows the ACFM response for a second rail containing a squat as well as a small number of moderate RCF cracks. The presence of a squat is identified by a rise in the ACFM sensor response, seen at the left hand-side of the diagram.

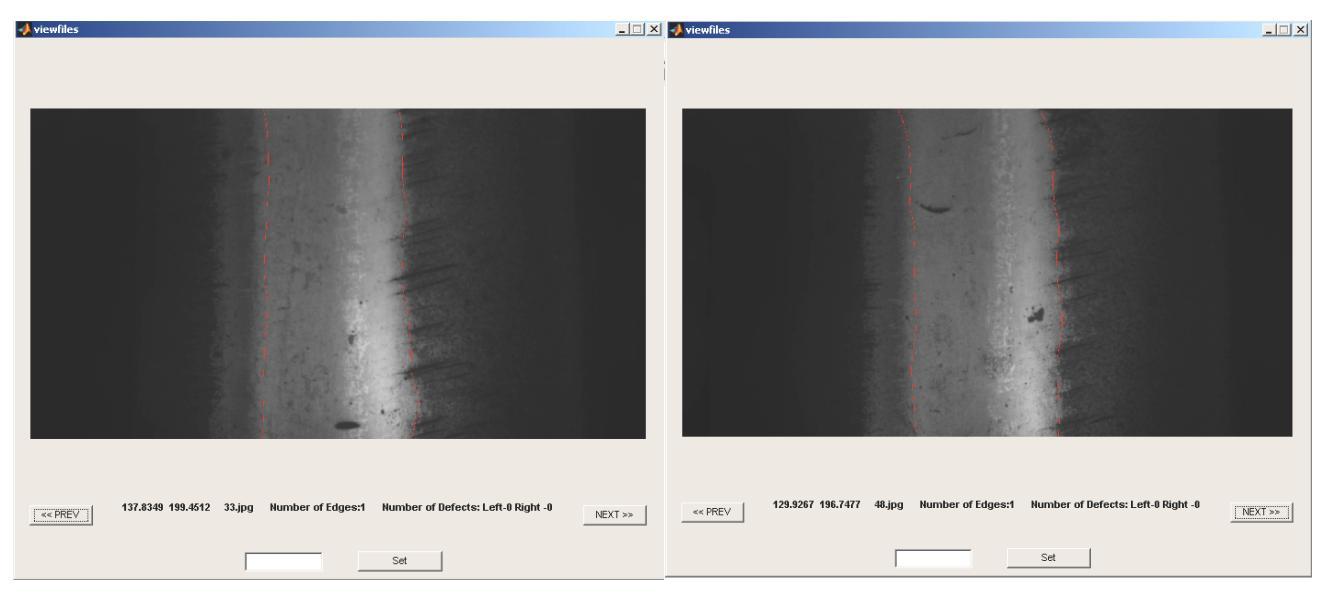
Figure 3.2 - Image analysis software detecting running bands

The software was used on several images to detect running bands, as shown by the red lines in Figure 3.2. This demonstrates that it is close to the actual observed position. Unfortunately, the lighting of the camera was suboptimal and therefore only the centre of the rail is visible in the pictures, with loss of resolution near to the edges of the rail head. In the section of track examined there were no significant deviations in the running band that indicated the presence of dipped welds or squats.

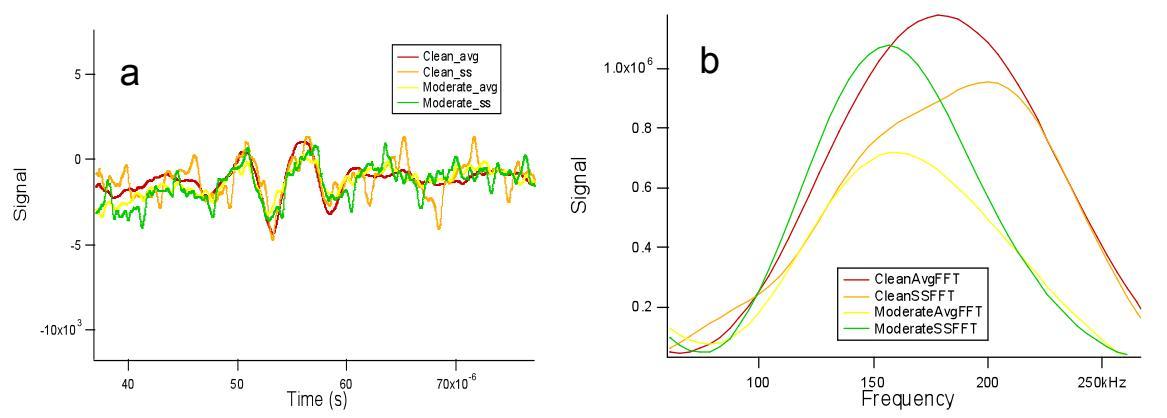
Figure 4.3 - time domain waveforms: (a) show evidence for some noise pick-up, (b) the FFT of these waveforms showing the frequency region with higher RCF that has a quantifiably lower frequency content

Typical waveforms recorded on areas of high and moderate RCF are shown below in Figure 4.3a, together with the associated Fast Fourier Transform (FFT) of the same data in Figure 4.3b.

As expected, the region with higher RCF appears to have higher attenuation of the higher frequency components, as lower frequency components are contained within a thicker region of the surface layer of the rail and pass under the cracks more readily.
